## NDE of Aerospace Components

**R.P. Singh, E. Madhava Rao and N. Vijay Shankar**  
Defence Metallurgical Research Laboratory, Kanchanbagh (PO),  
Hyderabad-500058.

Investment cast aerospace components are prone to defects related to solidification process. The hollow columnar-grained aero engine Vane casting, being discussed in this paper, suffers further from extraneous defects such as inclusions, core shift and resultant dimensional deviations. Due to its design complexity and stringent specifications, non-destructive evaluation (NDE) of this component is extremely difficult and critical. Complete inspection, employing different non-destructive testing (NDT) techniques, has been aimed to assess full inspectability and reliability of the components. Radiography, visual/ grain size inspection/ fluorescent dye penetrant test (DPT) after macro etching of the components, and ultrasonic wall thickness measurement (with an accuracy of  $\pm 0.02$  mm) of the aerofoil are the techniques utilized for complete inspectability. Innovative NDE methods and specially designed equipments have been used for the purpose.

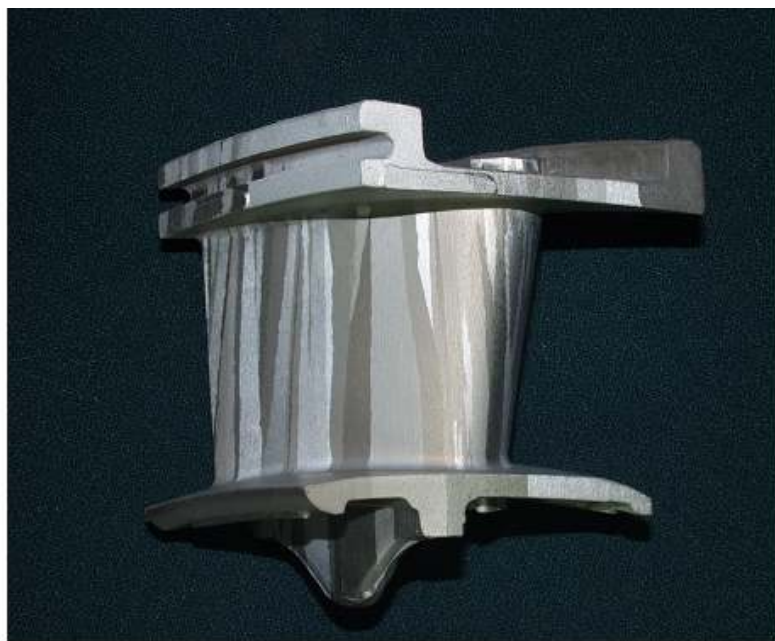
**Fig. 1. High Pressure Turbine Vane showing columnar grains after etching**

Fig.1 shows the turbine vane component under consideration. According to the changing profiles, in terms of thickness and orientation, a number of radiographic exposures had to be designed and standardized for effective radiographic evaluations. Innovative ideas were put to develop the exposure techniques. For the aerofoil portion (concave at one side and convex at the other side) single film single image technique was applied, also upside down. Again for the trailing edge and the leading edge separate exposures were designed. A high energy, high frequency 450 kV X-ray equipment having dual focal spot (1.5 mm & 4.0 mm) is being used for the purpose. Focal spot (target) is the area of the anode of X-ray machine which is struck by electron flux. With 1.5 mm focal spot and 4.0 mA current the voltage was varied from 105 to 190 kV for different 13 exposures. Wire type DIN penetrameters (Image Quality Indicators) were used to assess the sensitivity of exposures. To assess the flaws of size 0.25 mm and above, 16<sup>th</sup> DIN wire (0.10 mm dia) was used.

After visual examination, the components are macro-etched, Fig. 1 for grain evaluation. The columnar grains are examined for their width and angles with the stacking axes. A minimum number of grains per mid span chord and the maximum grain width are specified.

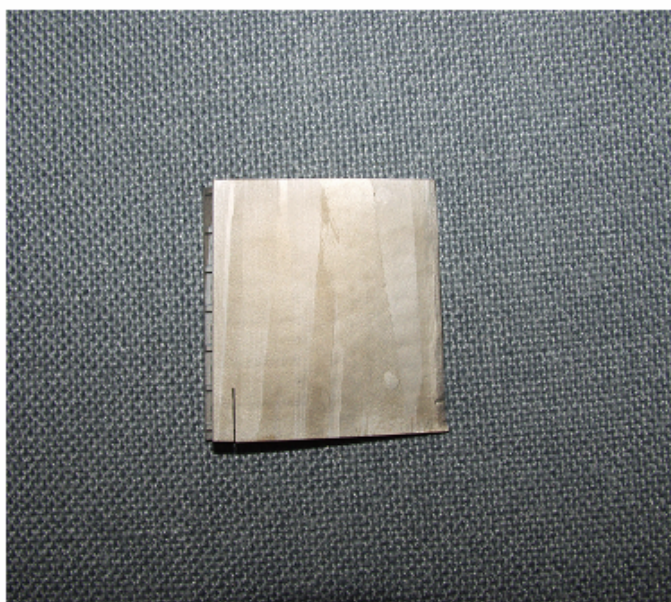
**Fig. 2(a). Showing etched columnar grains on the aerofoil.**

difficult. Idea of using different dia copper wires (0.2, 0.4 & 0.5 mm) is just brilliant. Anyway, defect length measurement is easy. Identification of the defects and their locations are recorded for reporting purpose. Defects depicted in Fig. 2 (a) & (b) are grain boundary cracks, typically related to the chemistry of the alloy and solidification process.

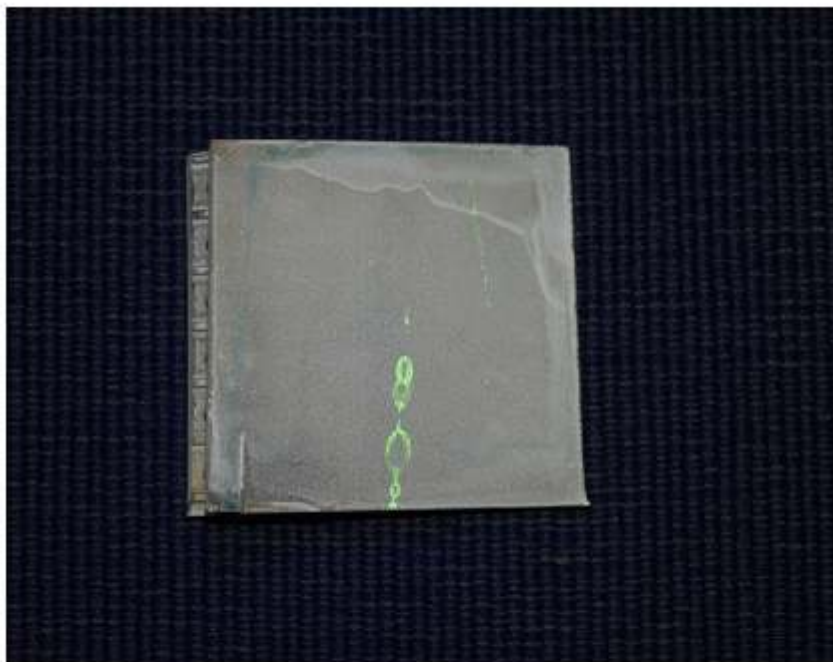
Fig 2(b). Showing grain boundary cracks in Fluorescent DPT.
